ANNUAL SUBSIDENCE REPORT
PLATEAU MINING COMPANY
1983

SUMMARY

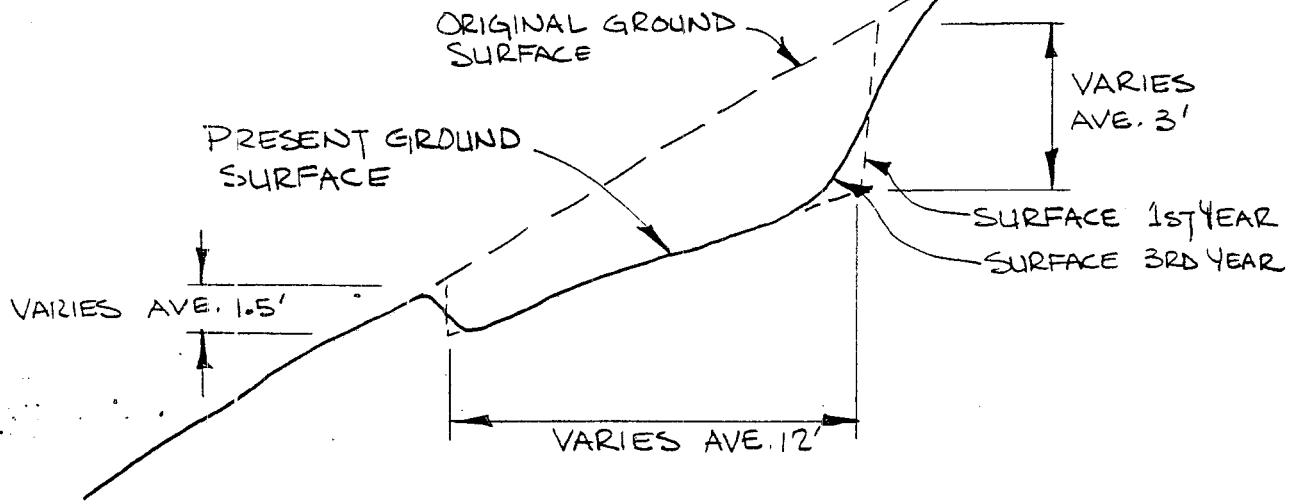
SECTION A-A

Surface effects consist of tension cracks both parallel with the slope and at a diagonal, holes and one area that slumped. Cracks range in width from a few inches to 3 feet. Holes range from 2 feet to 10 feet in diameter. Cross sections A-A and B-B on Plate I give typical details of two areas as shown on Plate 12-2, Sheet 1 of 4.

There is considerable evidence that the soil displacements are healing themselves, the older the cracks, the more healing is evident. Soil at the edges of the displacements is migrating into the crack seeking the angle of repose, refer to Section A-A and Photograph No. 7. More photographs and site measurements to document healing processes will be taken in 1984.
